Iron mining history along the North Country National Scenic Trail in the Grand Rapids area

The Tioga #2 Mine

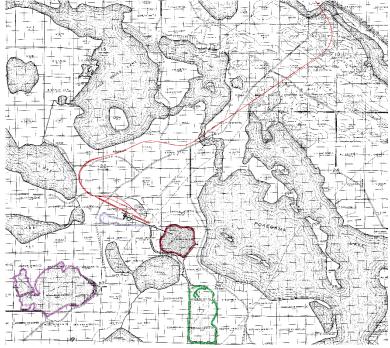
How did it operate: Until a rail line was put in, a road was built through the swamp and woods to reach the mine. The map at right is from the 1955 Great Northern Iron Ore Properties maps showing the rail line as went to the plant. The line traversed three different bridges and swamp to get to the mine. The rail line is shown in red. The mine itself is outlined in maroon, the stripping dump in green, the fines tailings basin in purple, and the coarse ore reject pile in light purple.

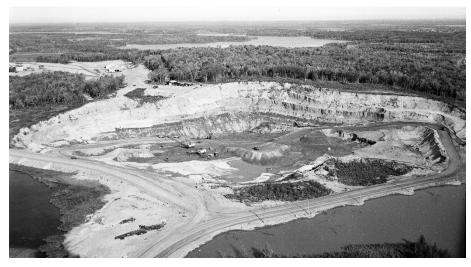
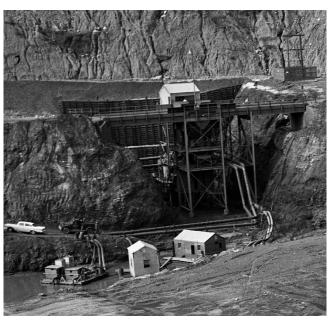
Located at the bottom of the mine, along the western wall, the pit pocket would allow trucks to drive

over a ramp to the top of the pocket. Their load would be dumped into a waiting bin below, and then driven off the other end.

The pit pocket consisted of a screening plant and crusher. The smaller material went through the screen and up the main conveyor up to the surface. The oversized material was crushed down to match that of the material that had already gone through the screen.

To reach the surface, a conveyor was built, traveling from the bottom of the pit pocket, to the surface. From the bottom of the pit, the conveyor would be routed through a tunnel. It was said, at the time it was built, it was the conveyor belt was the longest single section of conveyor on the world. Note: the spot where the conveyor's tunnel broke through to the surface is visible right off the NCT.

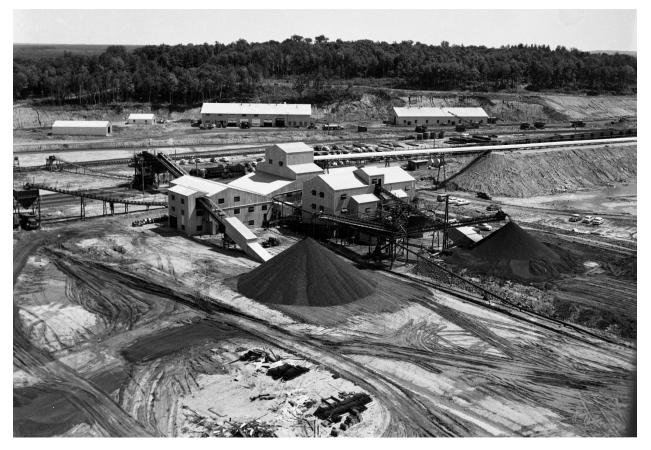
The conveyor would terminate at the top of the wash plant. The ore would be separated by size; the larger material (coarse), and the smaller material (fines).

Each had a different process for beneficiating the ore. Once separated, the ores were stored in separate surge piles outside the plant until it could be further processed.

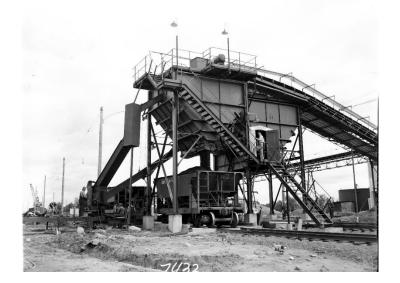
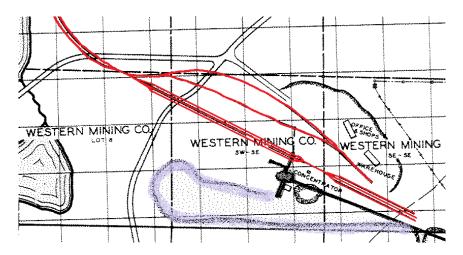
Once through the plant, the ores would be transferred to the rail loadout pockets. Both fines and coarse ores had their own loading pockets. Cars would be dropped by gravity from the tail tracks to the loadout pockets, spotted and loaded, then once again be dropped by gravity to the loads yard.

The Great Northern would deliver cars to the mine and shove them down the empties track to the tail tracks. They would then pick up the loads and head back to the main line. Note: the

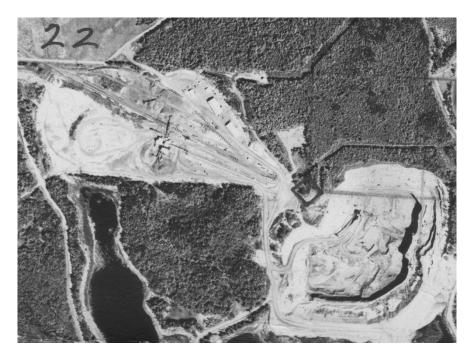
The Tioga #2 Mine operated until 1961 when it would shut down. Over the short life of the mine, 3.7 million tons of ore were shipped out from the property. By 1964, the structures, with exception of the shops and warehouse, were removed. A small operation called Iron Range Plastics would eventually move in. After that closed, Benes Well Drilling moved into the old buildings.

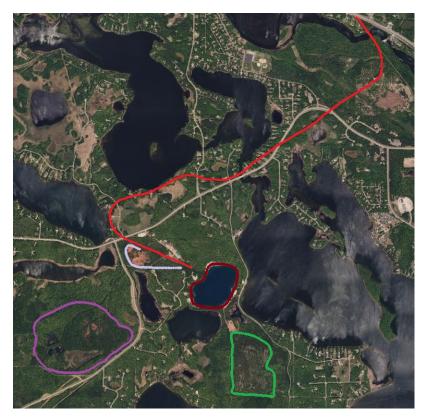
Today there isn't much evidence the operation was there. The pit and mine buildings are still there, but the coarse ore reject pile is slowly being removed as a source for road material. The fines tailing pond and stripping dump has been reclaimed by nature. Houses have popped up along and on the former GN roadbed.

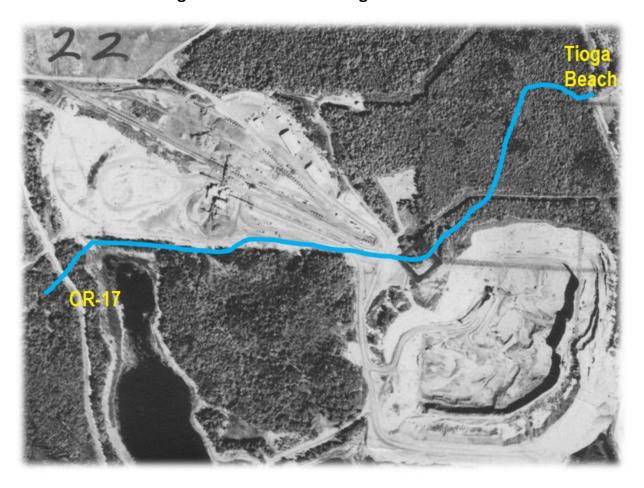
Where does the NCT go in relation to the Tioga #2 Mine facilities?

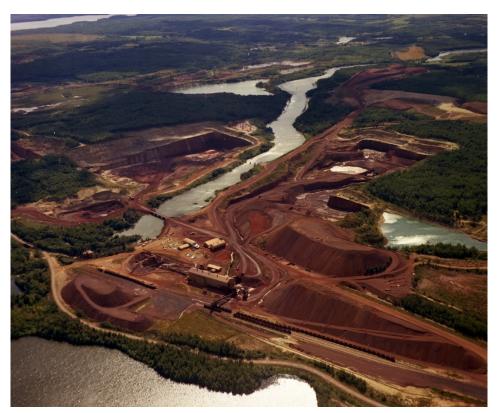
Who owned and ran it: This was a Jones & Laughlin operation that split the Prairie River. In the middle left of the picture you can see the pit wall for the West Hill.
